REFLECTIVE RADIANT BARRIERS

Good for Energy Savings – Bad for Fire Safety

Ronald Simmons, P.E., C.F.E.I.,
Eric Benstock, P.E., MIFireE, C.F.E.I
Nestor Camara, B. Sc., C.F.I.
MCDOWELL OWENS ENGINEERING, INC.

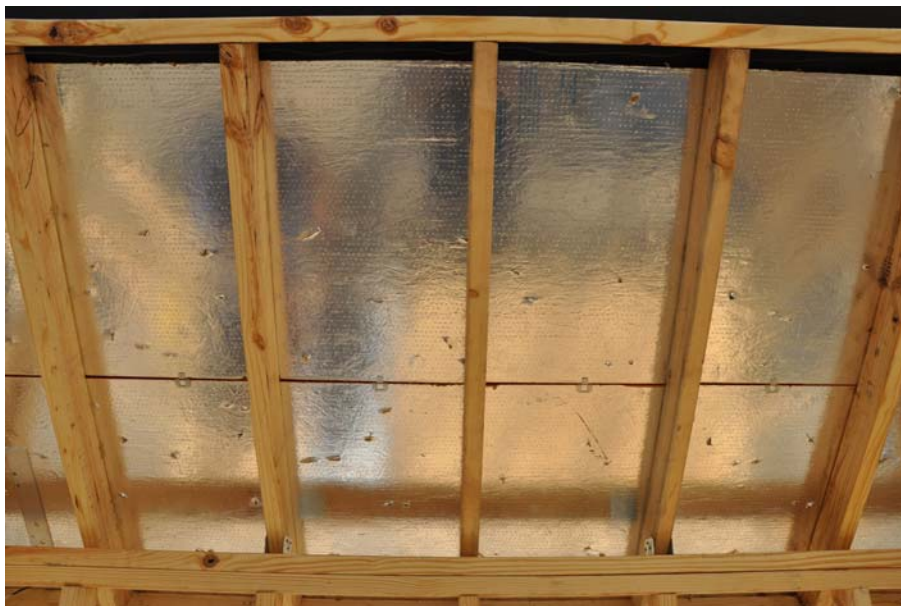
PHOTO #2

**A Typical Attic During Construction Using Roof Decking with Radiant Barrier Material Laminated on the Underside of the Sheathing
(this photo shows the metal plywood clips at sheathing seams)**

Because of the location of this barrier it would seem much more difficult for it to come into contact with sources of electrical energy. Therefore, we had hoped (and assumed) this application would be less likely than the attic floor installation to be a factor in fire ignition. Unfortunately, experiences in the months since our first report have shown this is not necessarily the case.

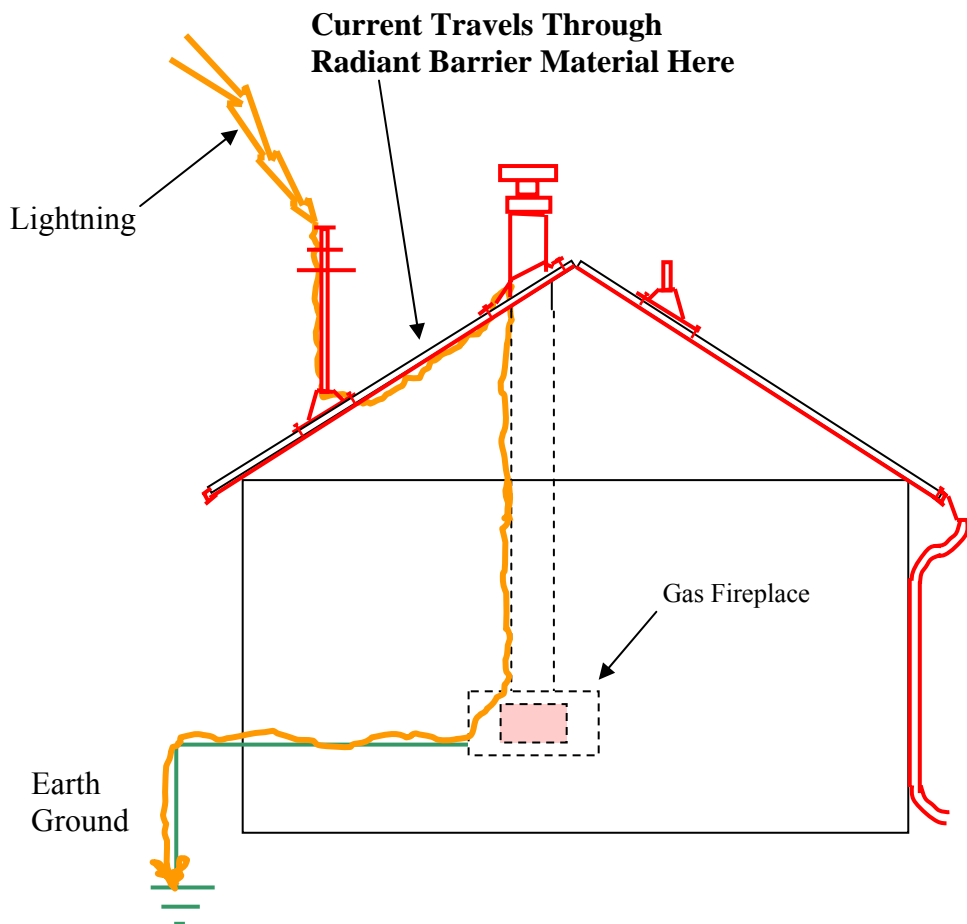
DIAGRAM 2
A Typical Path for Lightning Current

This brings us to the third incidental factor. With all of the many features and facilities on the roof, it is highly likely at least one of them will be bonded to an earth ground connection somewhere. It might be a water heater vent pipe, a gas fireplace chimney, an antenna, an electrical service entrance masthead, or any of dozens of possibilities.

Putting all the factors together we get a situation where the significant ramifications are as follows: if lightning strikes virtually anywhere on or very near the roof, it is highly likely the current will pass through at least a portion of the radiant barrier on the way to earth ground.

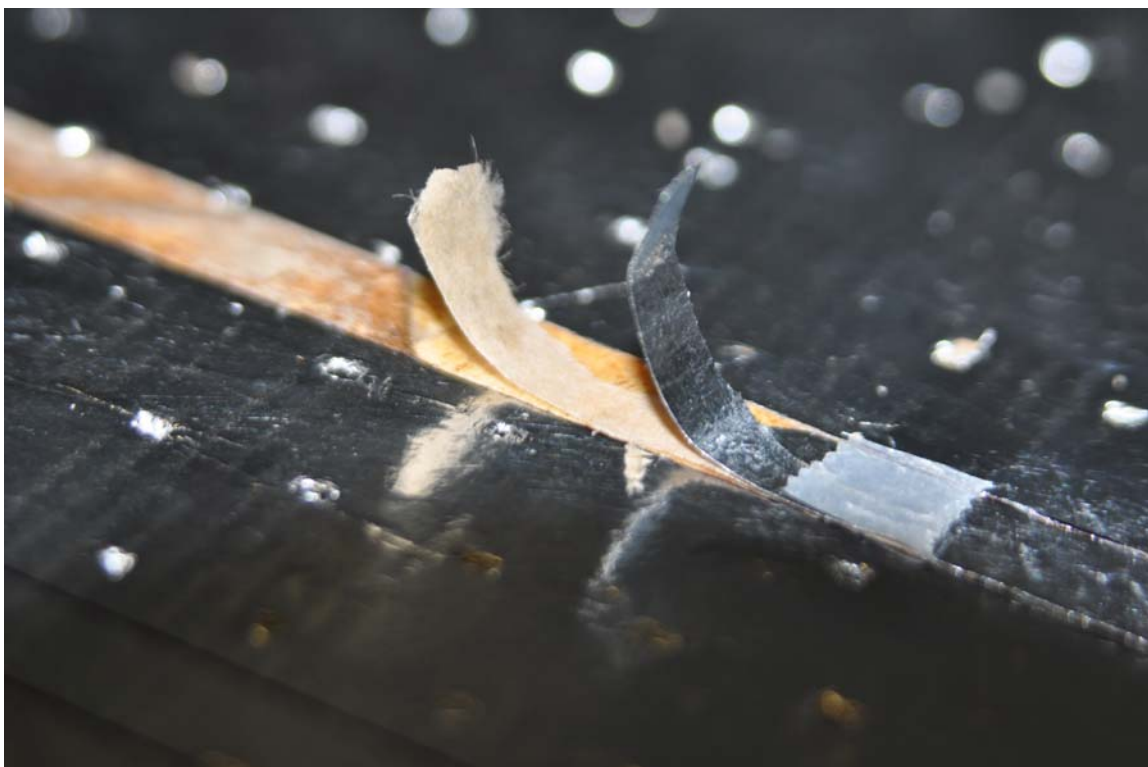
PHOTO #3

**Louisiana Pacific "Techshield" Roof Sheathing
A section has been cut and "peeled."**

This shows the layer of thin aluminum over a layer of paper.

The essential physical characteristics of the radiant barrier material which is glued to the underside of the roof sheathing were examined. We found that the material is comprised of two layers. The first layer (which is the one we see on the underside of the roof) is a sheet of aluminum which is approximately 0.01 mm thick. The second layer (between the aluminum and the wood sheathing) is a sheet of paper approximately 0.02 mm thick. These can be seen in photo number 3.

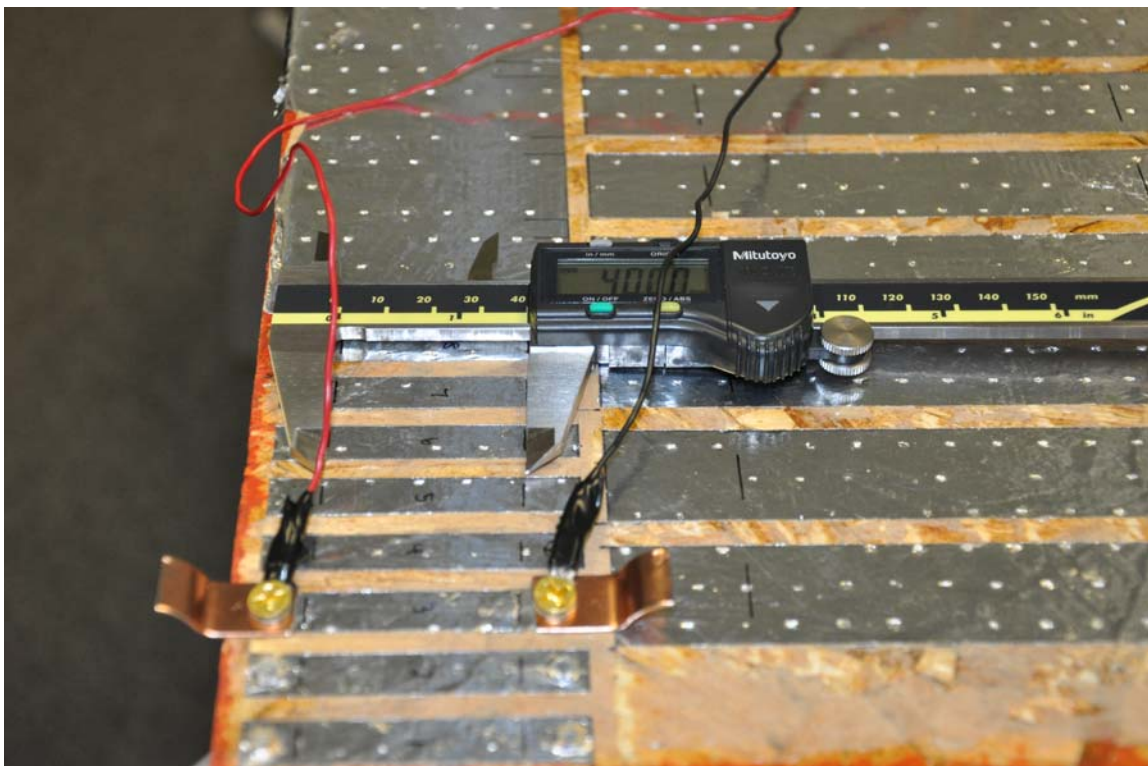
PHOTO # 4

Shows the two sets of sample test strips

One set 1cm wide x 4cm long

One set 1 inch wide x 4 inches long

For measuring and analyzing these parameters we needed some carefully prepared test strips of the radiant barrier material. Photo 4 shows the two different sets of test strips we used.

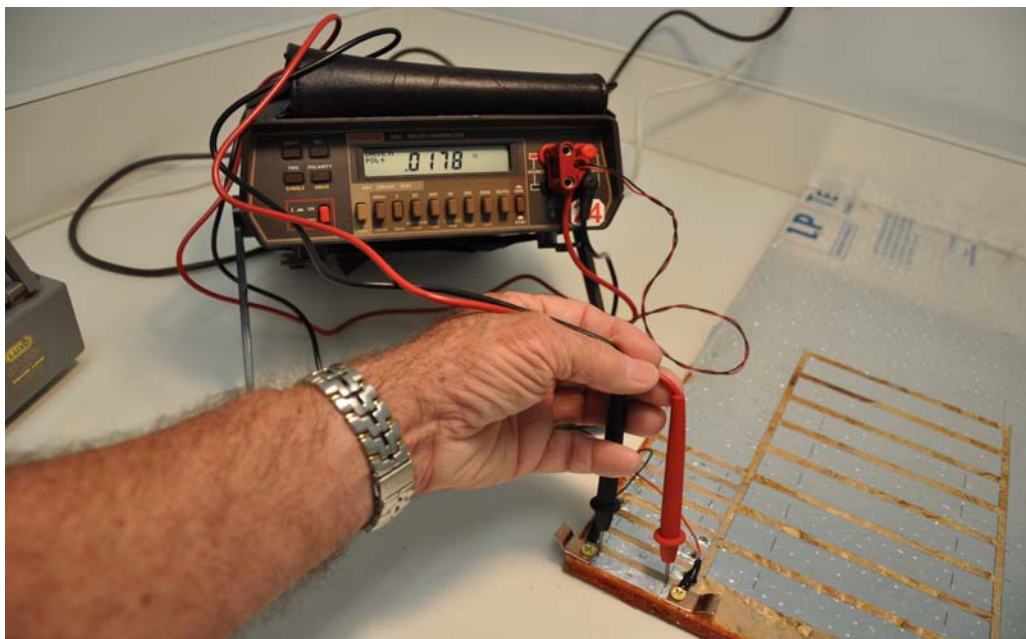
PHOTO # 5

Four Point Measurement of Test Strip Resistance

We performed four point resistance measurements on the test strips using a very accurate milliohm meter (as seen in photo # 5). We measured between 17.7 and 18.2 milliohms of resistance. Thus the theoretical value for pure aluminum test strips was about 35% lower than our measured value. This was actually about what we expected. Although we did not have the exact metal alloy composition analyzed, we can be virtually certain that the aluminum in these foils is not high quality “pure” aluminum. We can be highly confident that there are impurities in the aluminum and that the impurities will have the effect of increasing resistivity (Engineering Toolbox) (Fink) (Wikipedia). The fact that the theoretical values (for pure aluminum) differ from measured values in the direction we expected and by about the amount we expected provides us with a good “sanity” check

on our measurement methods. The measurements we made were highly repeatable across samples, from reading to reading and over time, so we are very confident in these values. Since our test strips have an aspect ratio of 4:1, that gave us a sheet resistance value of 4.50 milliohms per square. To further confirm this value, we created test strips which were one inch wide by four inches long and repeated the four point measurements. Once again our measurements read between 17.9 and 18.4 milliohms. We are highly confident that the actual sheet resistance for the particular piece of roof sheathing we tested is very near the value of 4.50 milliohms per square.

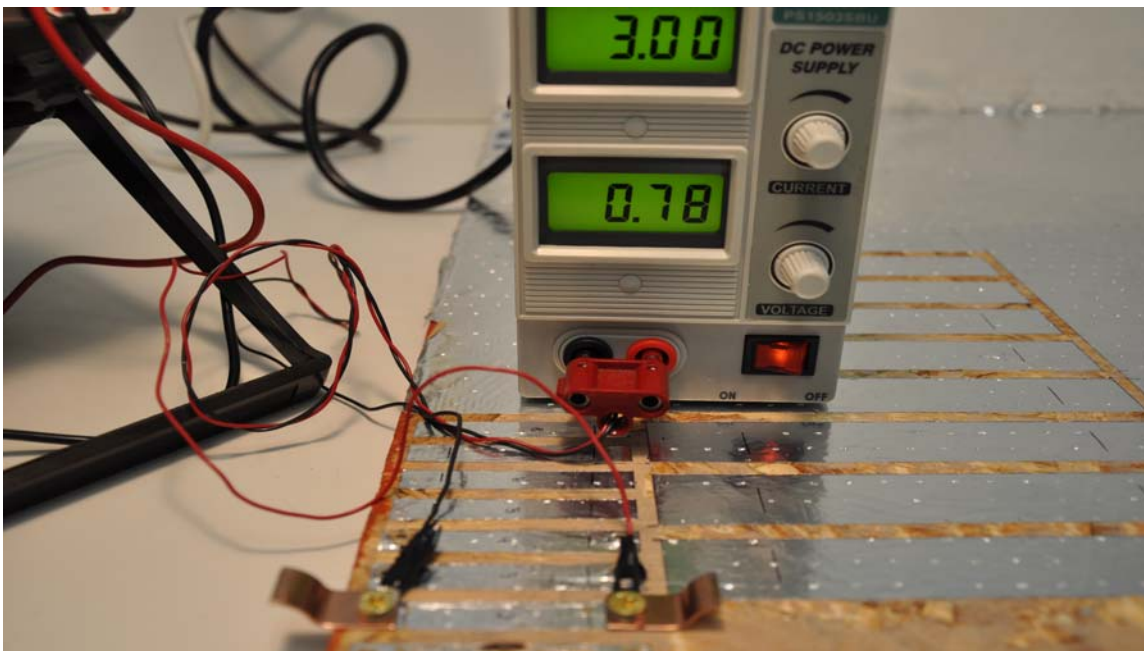
PHOTO # 6
Forcing 3.00 Amps Through a One Millimeter Test Strip

From experience in the semiconductor industry we knew that the current density at which aluminum conductors actually fail can be much greater than 10 Amps per square millimeter. Our bench power supply had accurately adjustable current output up to slightly more than 3 amps. In order to achieve the needed current densities at these low current levels we needed a test strip with a small cross sectional area. We created strips which were one millimeter wide by “splitting” our original one centimeter strips.

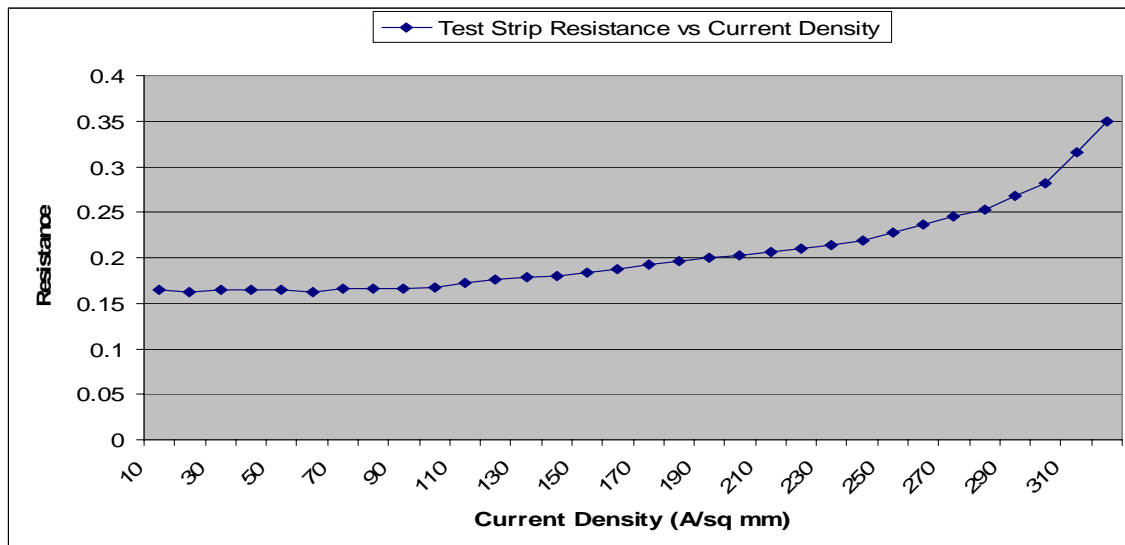
At 0.1 amp intervals from 0 amps to 3.2 amps we carefully measured the voltage drop, then used this to calculate the effective resistance at each value. The variations in test strip resistance versus current density are shown in chart #1.

CHART # 1
Test Strip Resistance vs. Current Density

The current density versus resistance measurements revealed two very valuable pieces of information. First, at levels above approximately 200 Amps per square millimeter, resistance of the material begins to increase rapidly (see chart 1 above). Second, at levels around 300 Amps per square millimeter our material quickly ignites and sustains flame. It should be noted that the material will ignite at current densities much less than this value (maybe 50% less) if enough time is allowed.

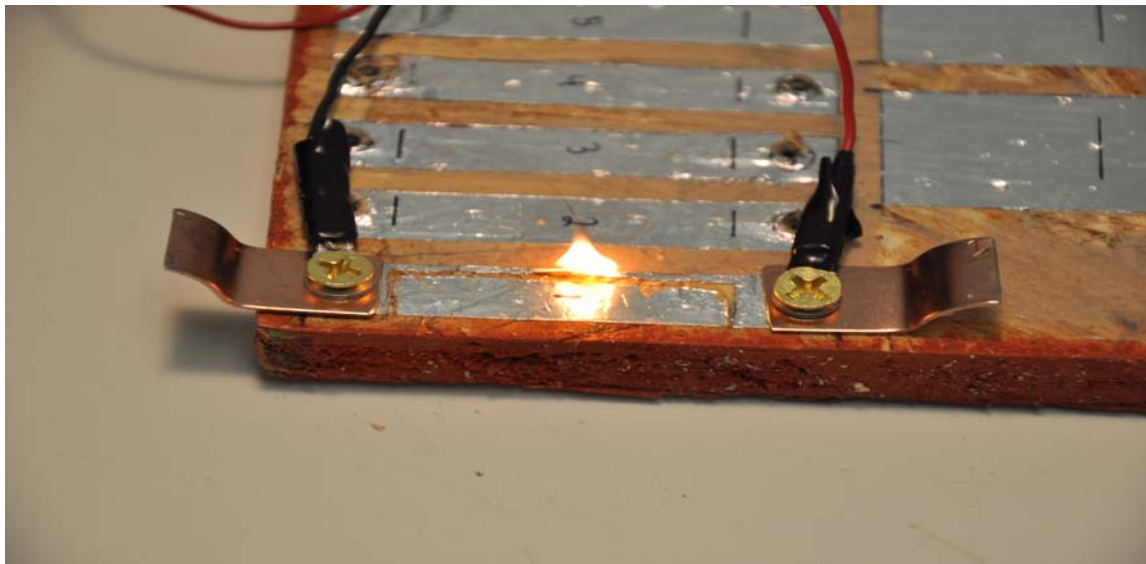
PHOTO #7

At a current density level of slightly under 300 amps per square millimeter, the material ignited and sustained flame. This is clearly seen in photo #7.

Test Strip Ignites at a Current Density of 300 Amps per Square Millimeter

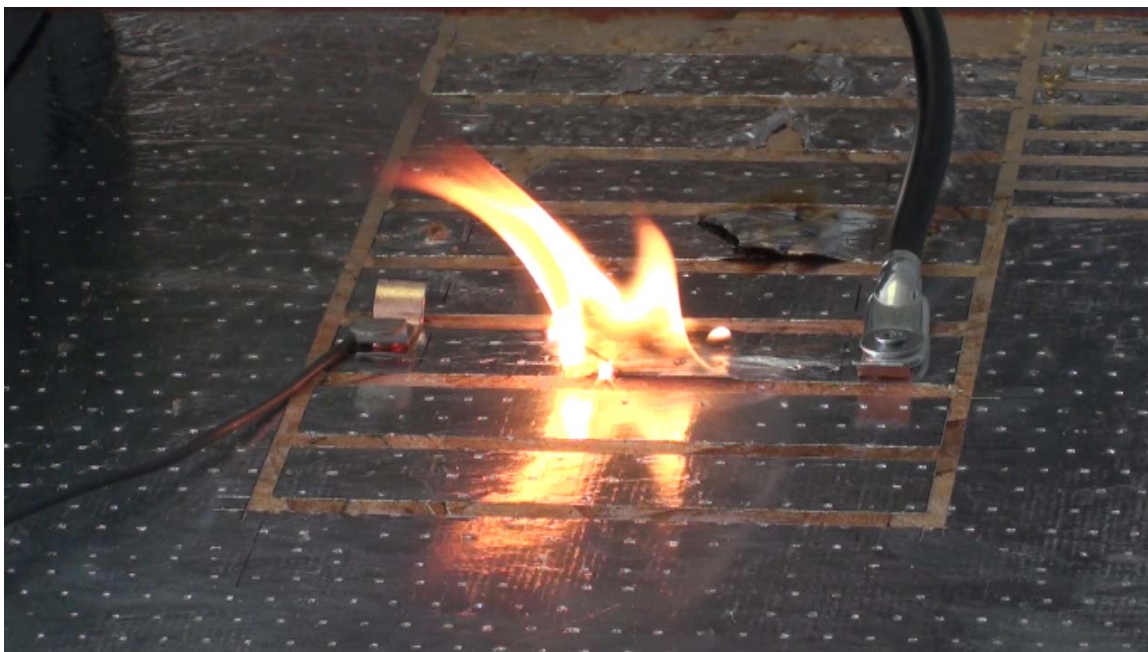
PHOTO #8

One Inch Wide Test Strip Energized With Current of Approximately 50 Amps

behave actually (not theoretically) when energized with large amounts of current?" In order to study this condition we conducted a series of tests. First we energized our larger test strips with a current of approximately 50 amps. Next we used a typical plywood clip to connect two large pieces of roof sheathing, which we energized with approximately 50 amps. Finally we constructed a small actual roof section. We energized portions of the roof decking which would conduct through a single plywood clip. Then we energized a section which would conduct through a clip covered with a typical rafter vent channel. The results of these tests can be seen in photos 8 thru 11.

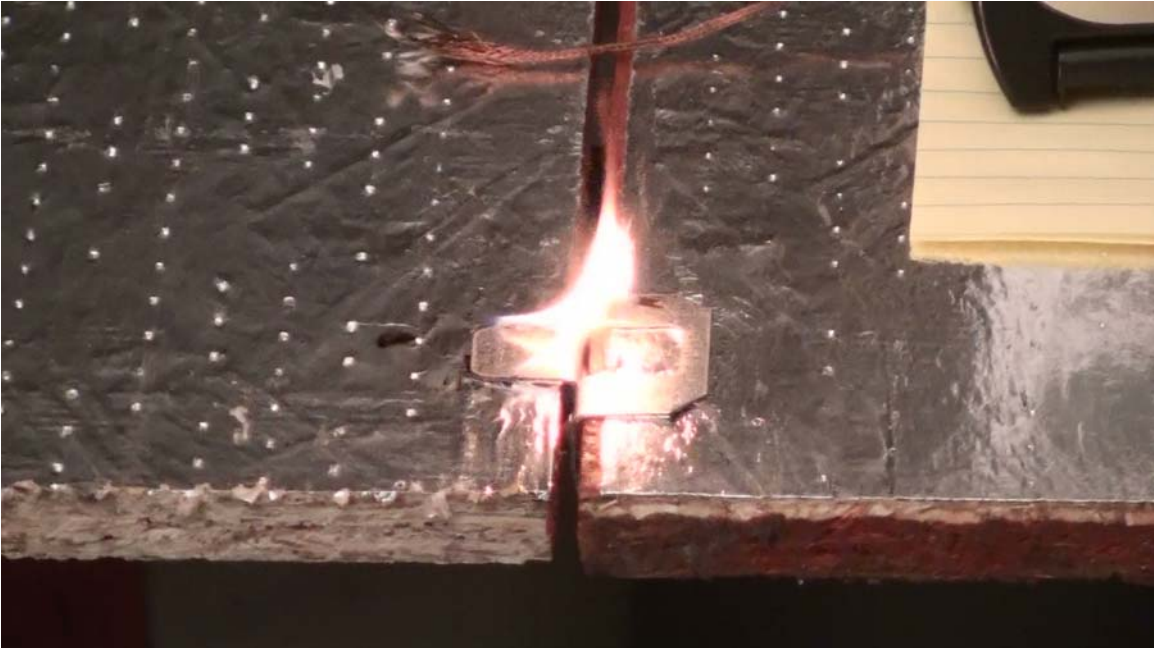
PHOTO #9
Roof Sheathing and Clip Energized With Current of Approximately 50 Amps

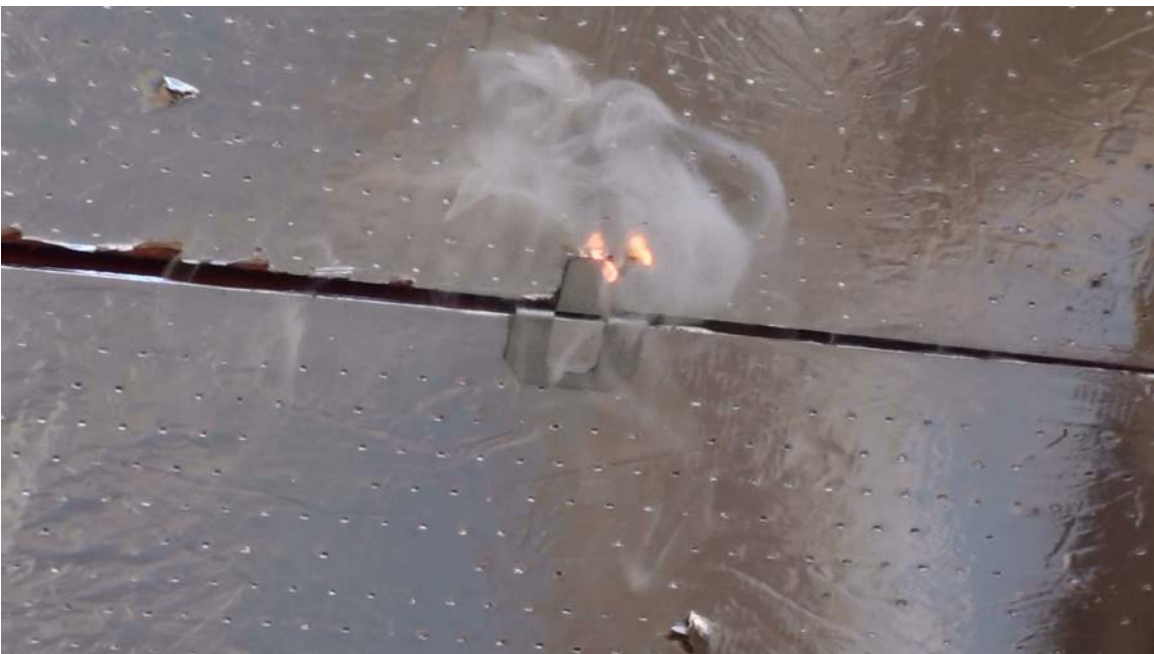
PHOTO #10
Plywood Clip on an Actual Roof Section – Approximately 50 Amps.
(Note that it is the barrier material which is igniting. This is because the current in the foil is “funneled” near the clip, thus the current density is highest near the clip)

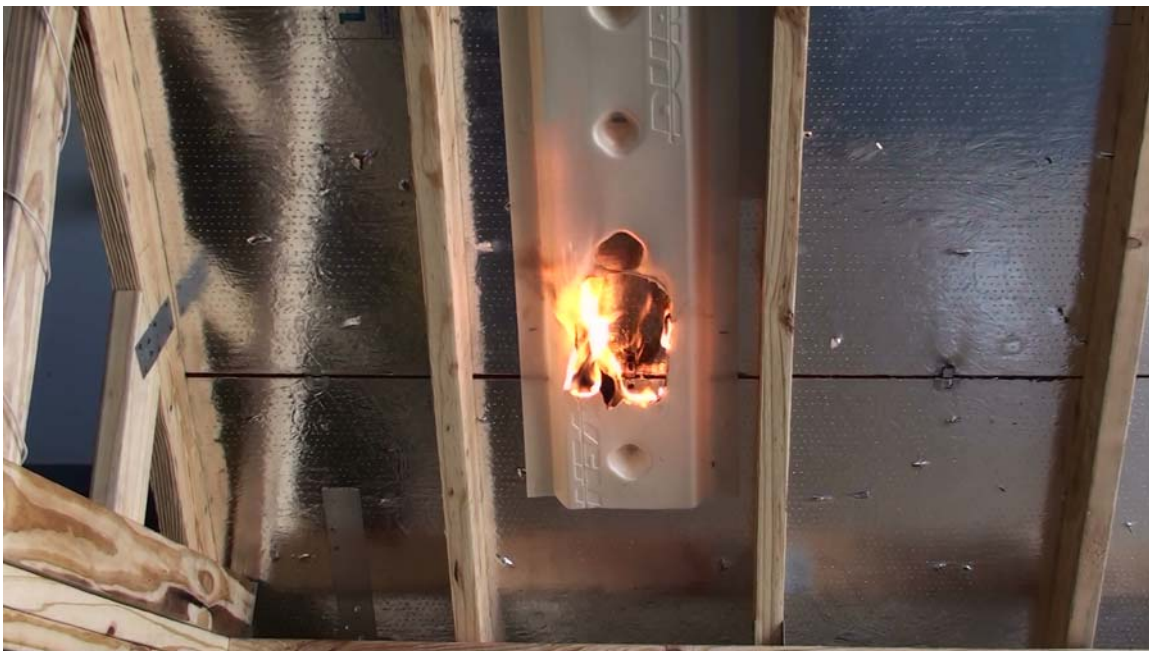
PHOTO #11
Underside of Roof Deck – With Soffit Vent Channels Installed
Radiant Barrier was Energized with 12 volts @ 50 Amps

The results demonstrated in these photographs conclusively answer the questions about how the radiant barrier material reacts in larger scale tests and in actual installations. When energized and heated by electric current flow, the material readily generates heat beyond ignition temperatures of many materials. The barrier material itself becomes the first ignited material as it quickly burst into flame. If there are other flammable materials nearby (such as soffit vents channels) that material is easily ignited and the fire spreads quickly.

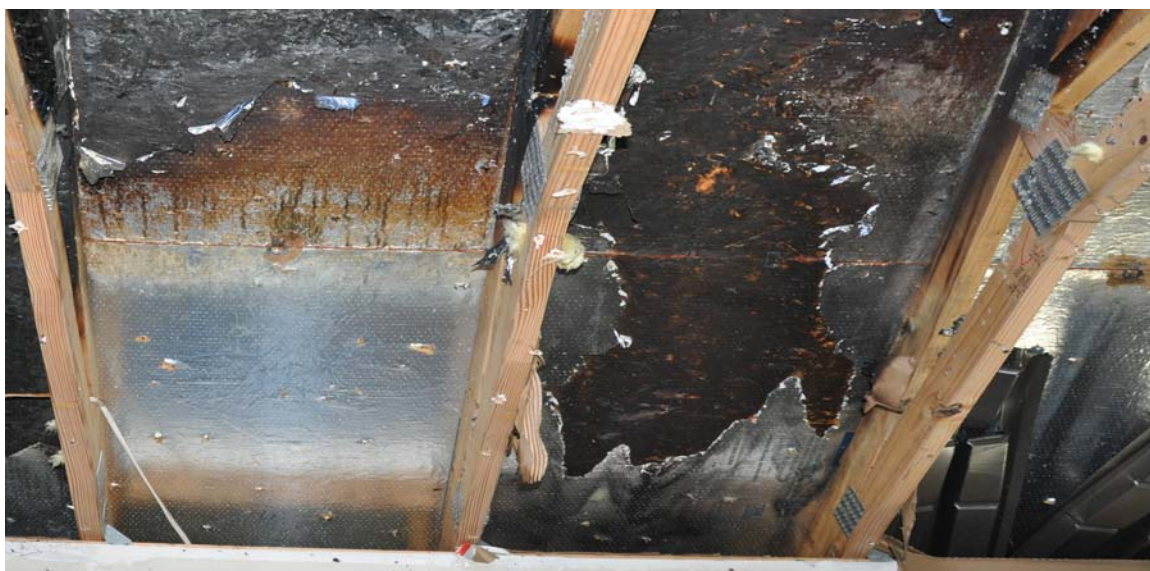
Photo # 12

Photo from an Actual Attic Fire After a Confirmed Lightning Strike

In photograph 12 note the clear evidence of localized heating and barrier material burning around the metal sheathing clips.

Obviously, any time a radiant barrier equipped structure experiences a fire when there is evidence of a lightning strike, an examination of the barrier material should be included in the investigation.

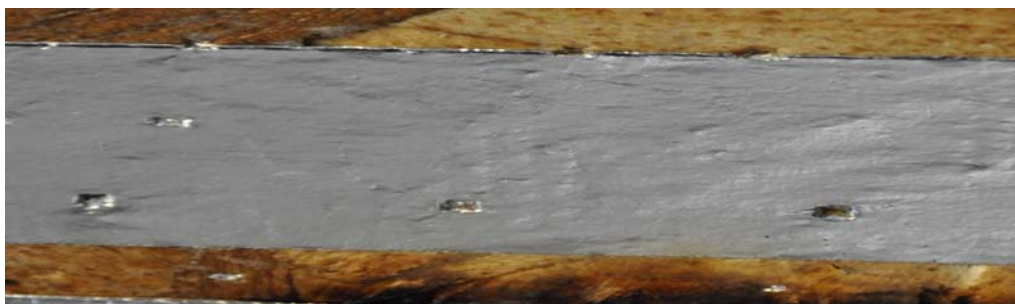
PHOTO #13

A Test Strip Which Has Not Been Subjected to Electrical Current

All investigators know that fire destroys a lot of evidence. After a fire, physical evidence which may have provided clues about the origin of the fire may be significantly changed or completely destroyed. If there are indications that radiant barrier material may have been causally involved, and if some of the material is available which has not been subjected to a high amount of radiant heat from the fire, there are some possible indicators which may be examined. We found that electrical heating of the material seemed to generate some distinctive patterns. Photos demonstrate some of these patterns.

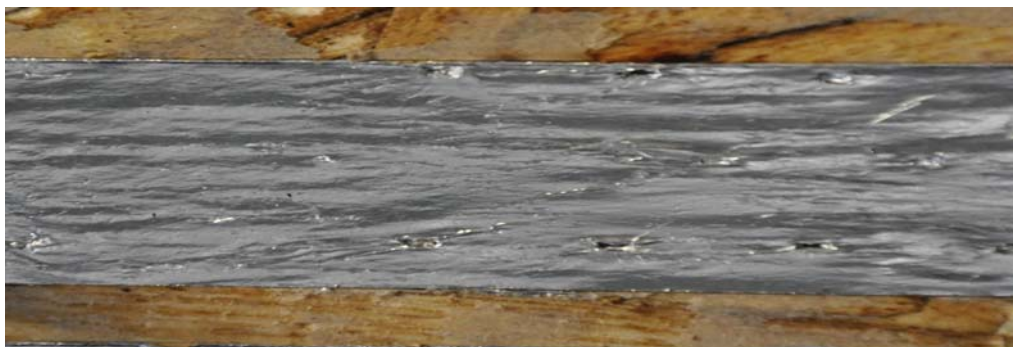
PHOTO #14

A Test Strip Which Has Been Heated Slowly By Approximately 30 Amps

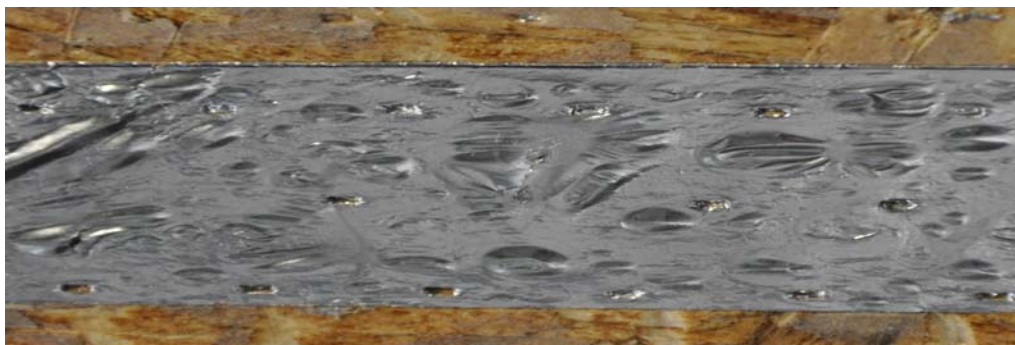
PHOTO #15

A Test Strip Which Has Been Heated Quickly By Approximately 100 Amps
